RAWSON-NEAL PSYCHIATRIC HOSPITAL

Site Number: 9894
STATE OF NEVADA PUBLIC WORKS DIVISION
FACILITY CONDITION ANALYSIS

Report distributed in August 2022

SPWD Facility Condition Analysis - 9894

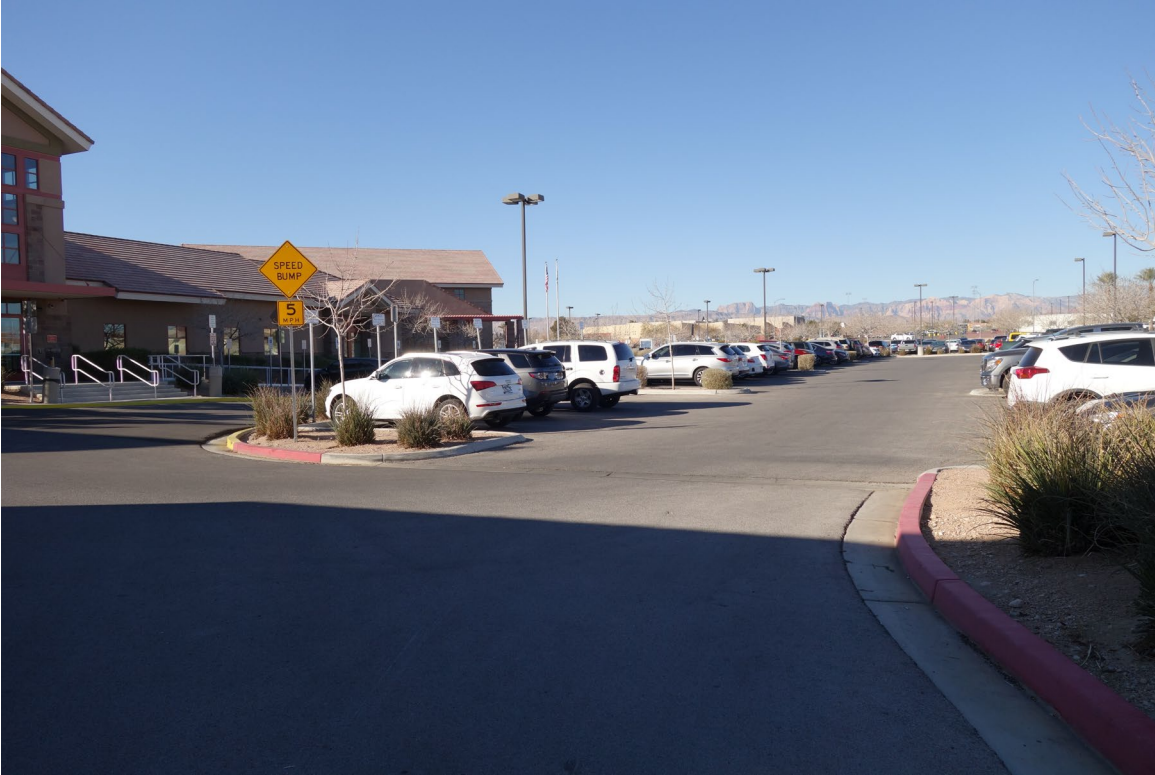
Rawson-Neal Psychiatric Hospital Site – FCA Site #9894
Description: View of the AC Paved Main Parking Area.

It is important to maintain the asphalt concrete paving on the site. This project would provide for minor crack filling and sealing of the paving site wide including access roads and parking areas. Striping is included in this estimate. This project should be scheduled on a 5 year cyclical basis to maintain the integrity of the paving and prevent premature failure. 164,000 square feet of asphalt area was used to generate this estimate.

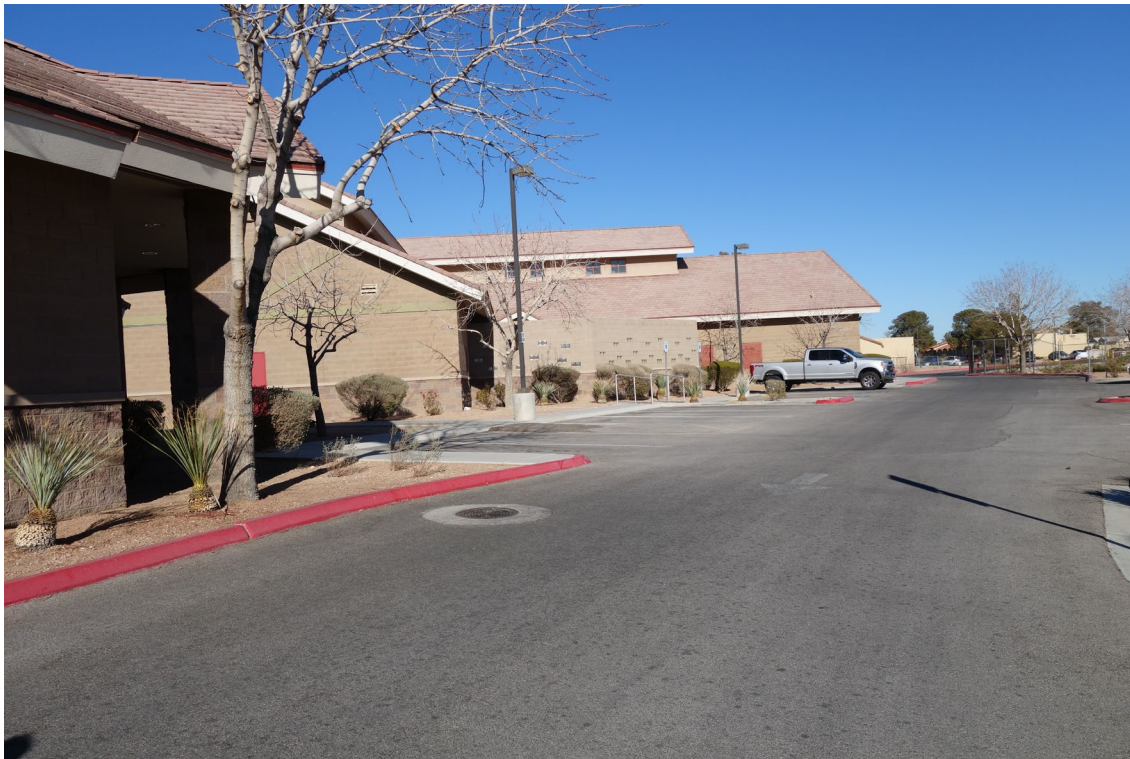
Rawson-Neal Psychiatric Hospital Site – FCA Site #9894
Description: View of the AC Paved East Parking Area.

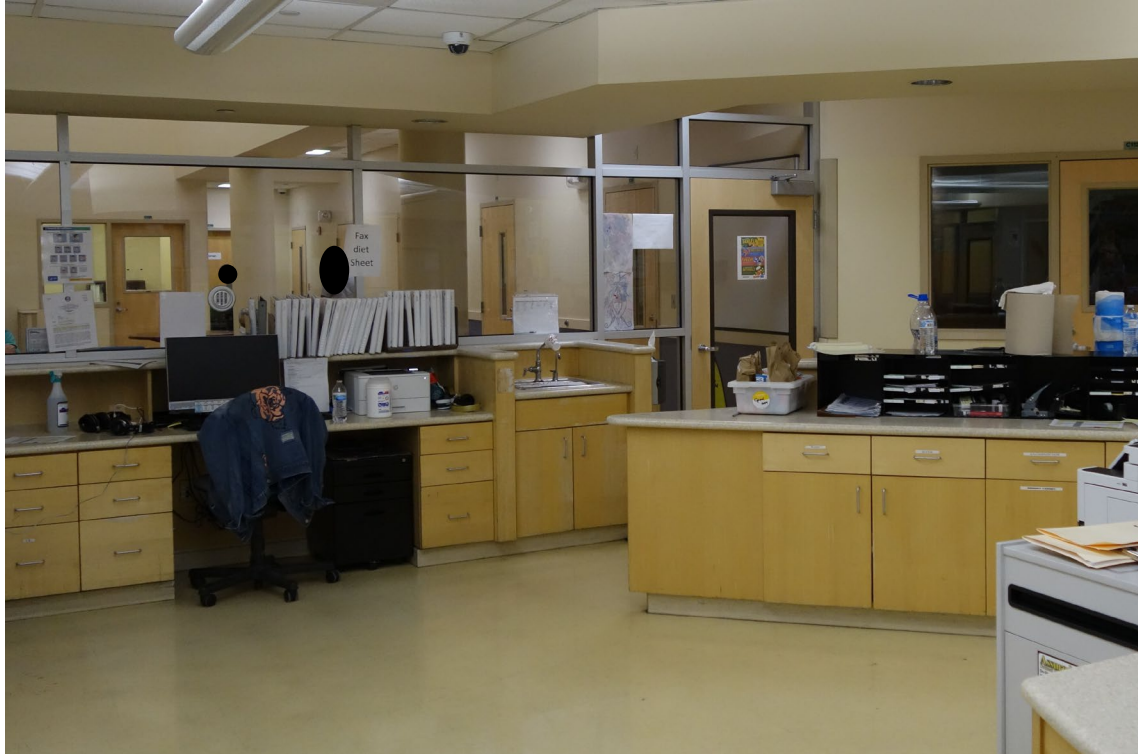
The deteriorating millwork at the Nurses Stations reduce the useable working space for staff and the debris may lead to infection control issues. This project will design and construct a repair to reface the millwork at the 2 Nurses Stations.

Rawson-Neal Psychiatric Hospital – FCA Building #2508 and #2510
Description: Typical Nurses Station.

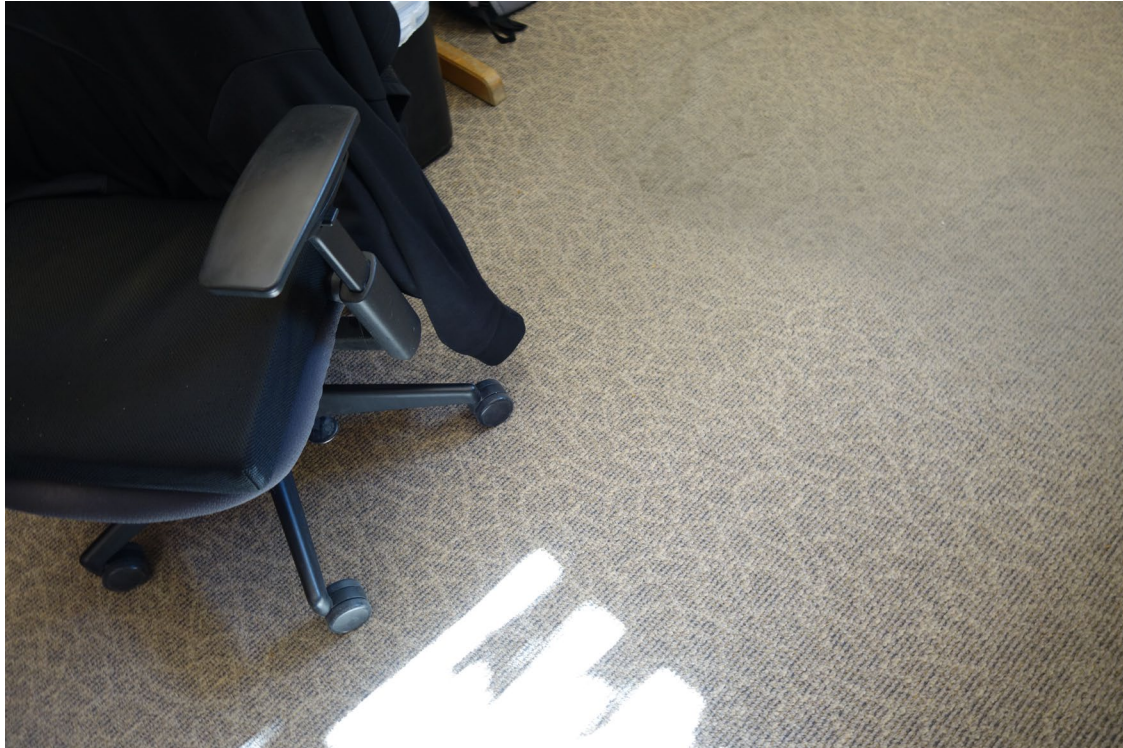
The carpet in the building is showing signs of extensive wear and should be scheduled for replacement. It is recommended that the carpet be replaced with heavy duty commercial grade carpet in the next 2 - 3 years.

Rawson-Neal Psychiatric Hospital – FCA Building #2508 and #2510
Description: Office Carpet Replacement Needed.

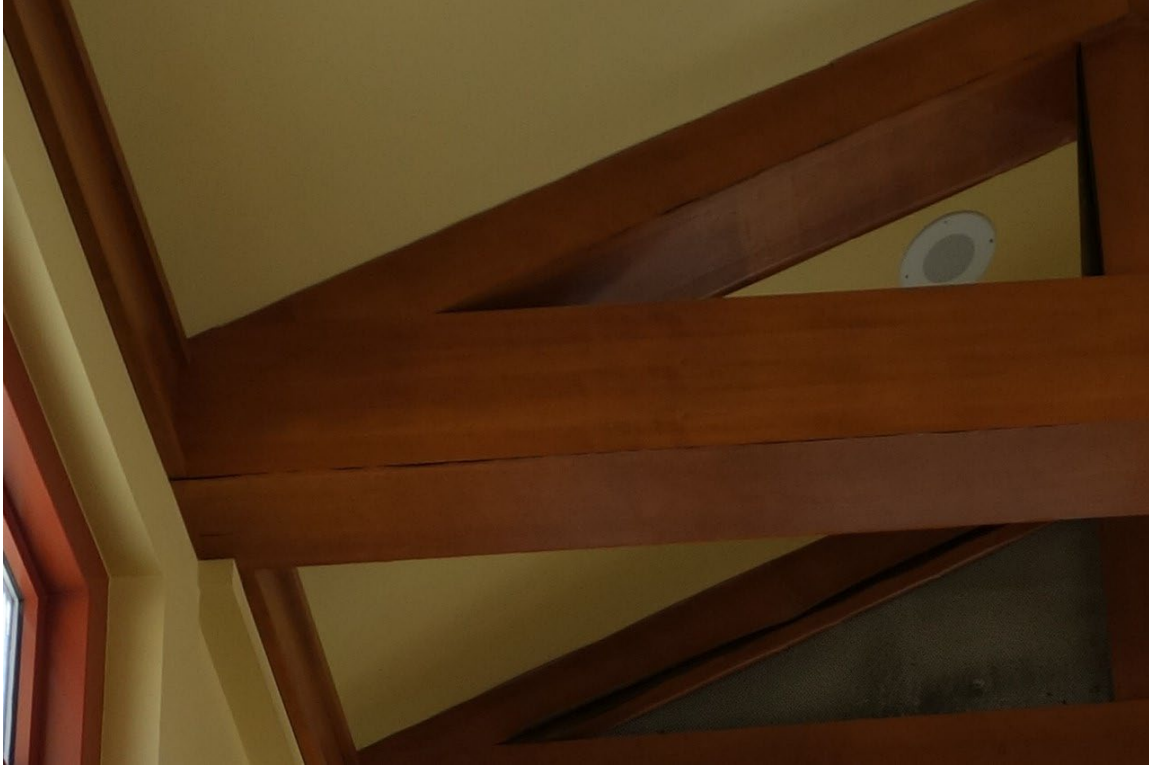
The millwork on the overhead beams in the lobby is deteriorating due to heat in the vaulted ceiling area resulting in a falling debris hazard. If these items are not repaired, it will result continued safety concerns and possible closure of the main lobby. This project will design and install laminates on the lobby beams suitable for the environment.

Rawson-Neal Psychiatric Hospital – FCA Building #2508 and #2510
Description: Delaminating Beams in Lobby.

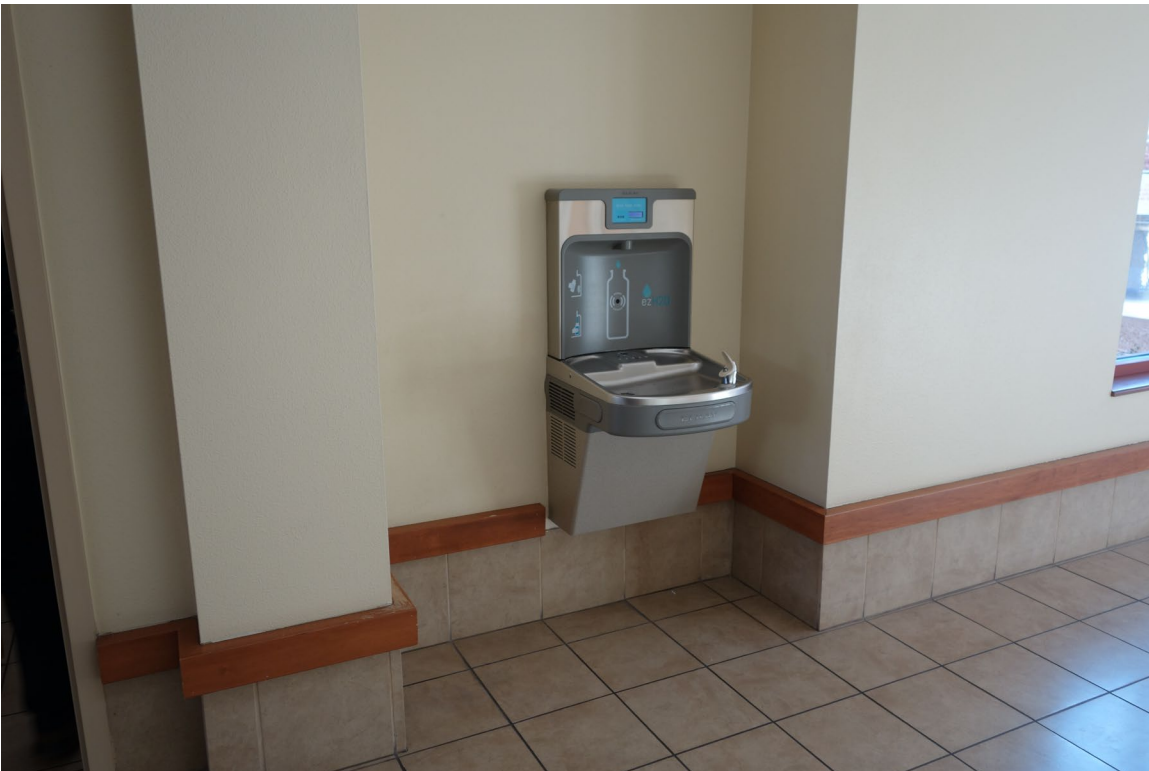
This building contains a water fountain in the lobby that is not ADA compliant. The 2018 IBC Section 1109.5 states where drinking fountains are provided on an exterior site, on a floor or within a secured area, no fewer than two drinking fountains shall be provided. One shall comply with the requirements for people who use a wheelchair and one shall comply with the requirements for standing persons. This project would provide funding for the purchase and installation of a drinking fountain to meet the ADA requirement. Note that a bottle filler integrated into a drinking fountain does not make the water fountain accessible. If drinking fountains are located in an exit access, it is recommended to review exit access requirements for projections into exit access width.

Rawson-Neal Psychiatric Hospital – FCA Building #2508 and #2510
Description: Dual Level Drinking Fountain Needed.

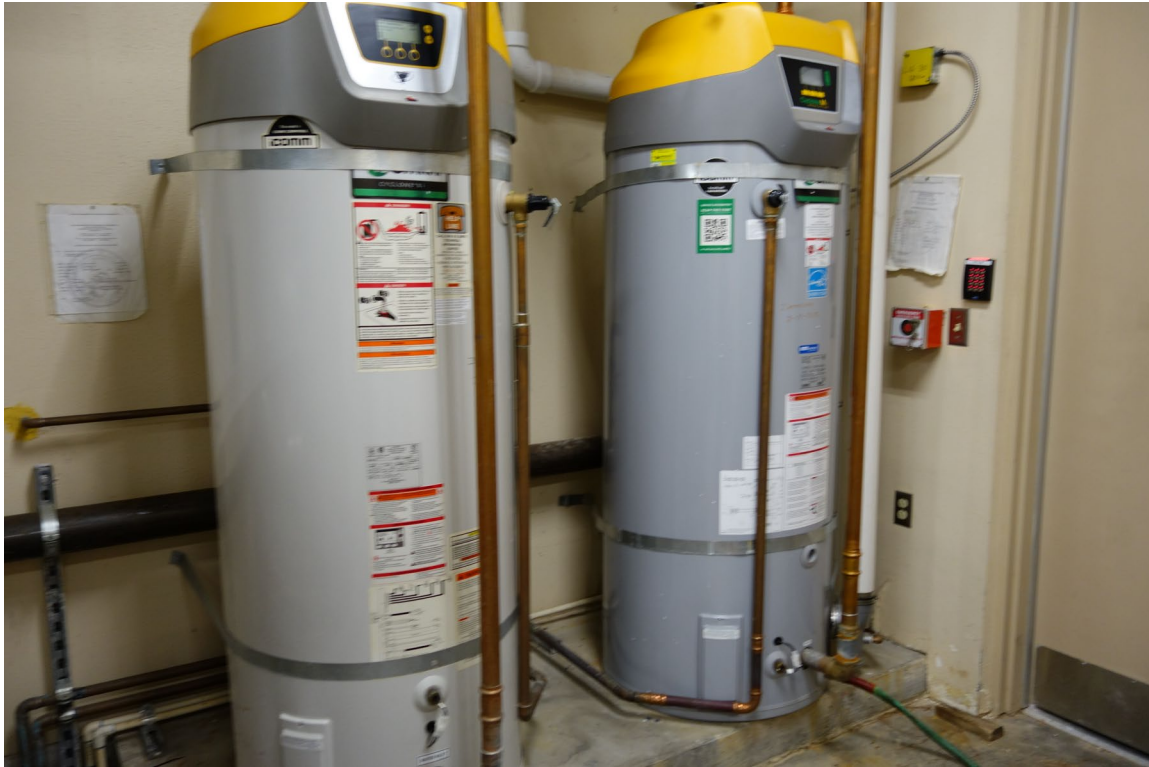
There are two 100 gallon natural gas-fired water heaters in the building. The average life span of a water heater is eight to ten years. One was installed in 2010 and the other in 2016. With the passage of time and constant use, the units should be scheduled for replacement in the next 3 - 4 years. They are also missing drip pans. It is recommended that new gas-fired water heaters be installed with seismic bracing and drip pans. Removal and disposal of the existing equipment is included in this estimate.

Rawson-Neal Psychiatric Hospital – FCA Building #2508 and #2510
Description: Water Heater Replacement Needed.

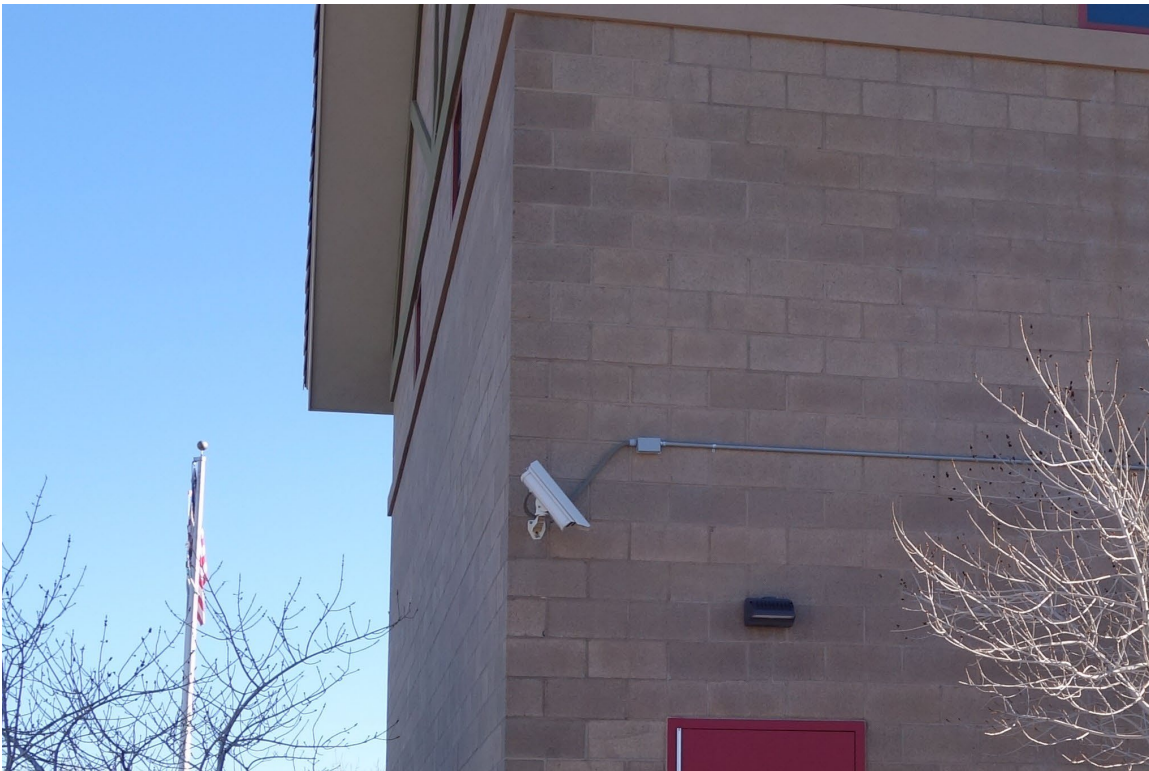
The video security system is outdated and some of the cameras do not function consistently. This project addresses replacement of the cameras and controls in the building with all digital equipment as well as sufficient storage capacity. Removal and disposal of the existing equipment is included in this estimate.

Rawson-Neal Psychiatric Hospital – FCA Building #2508 and #2510
Description: Security Surveillance Upgrade Recommended.
