# ***WALKER LAKE STATE RECREATION AREA***

SITE NUMBER: 9915

FACILITY CONDITION ANALYSIS

State of Nevada Department of Conservation & Natural Resources  
Parks Division/Walker Lake State Recreation Area  
Facility Condition Analysis

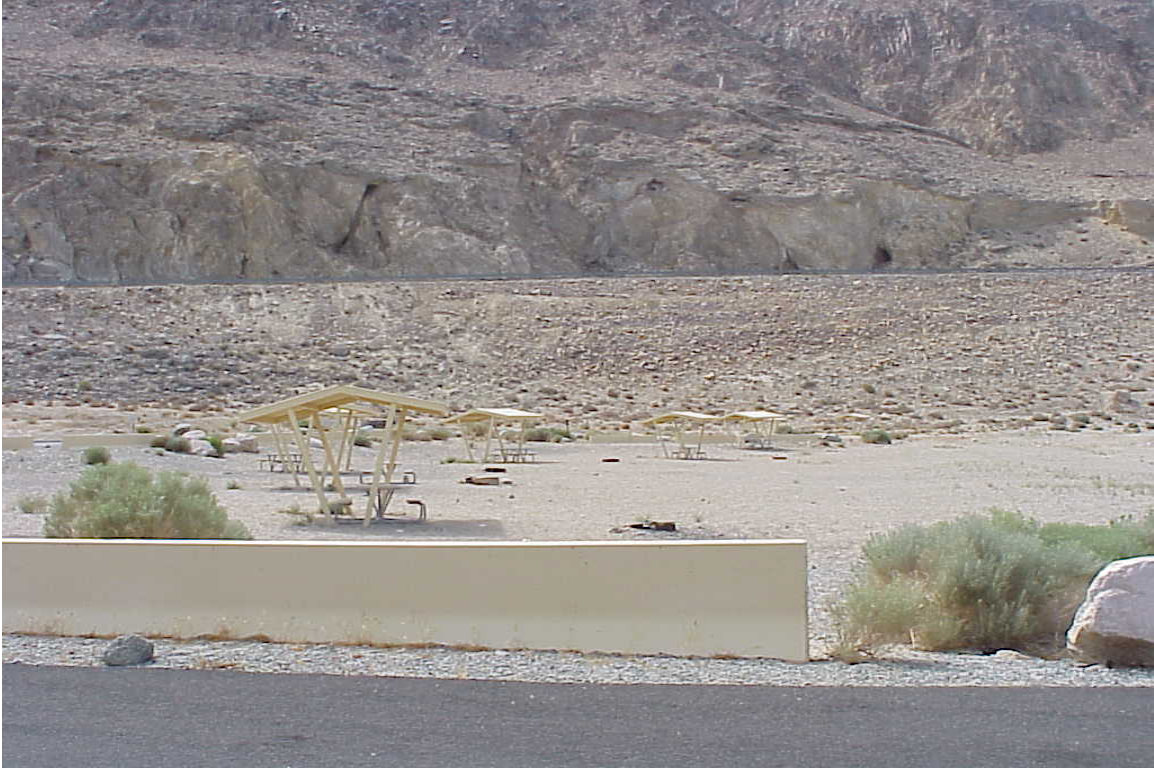
There are five freestanding ramadas, two porta-potties in a permanent enclosure, and a trash enclosure.

Walker Lake State Recreation Area Site #9915  
Description: View of ramadas.

This project recommends painting the structures to maintain them in good condition.

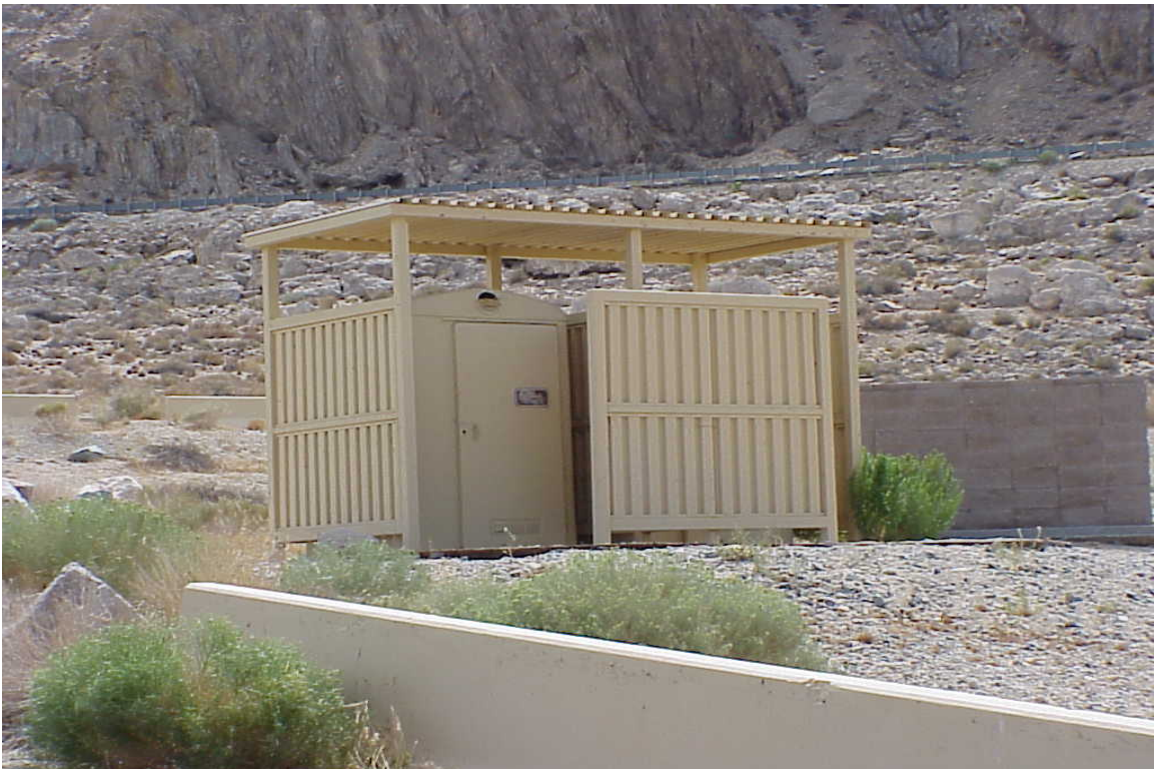
The restrooms at this site do not meet the Americans with Disabilities Act (ADA) regulations. A unisex restroom is recommended to comply with CABO/ANSI A117.1-1992 Sections 4.15 - 4.20 and 1997 UBC Chapter 11. This work typically includes construction of a new accessible restroom within the existing building footprint, containing a water closet, sink, grab bars, faucets, mirrors, dispensers and hardware.

Walker Lake State Recreation Area Site #9915  
Description: View of comfort station.

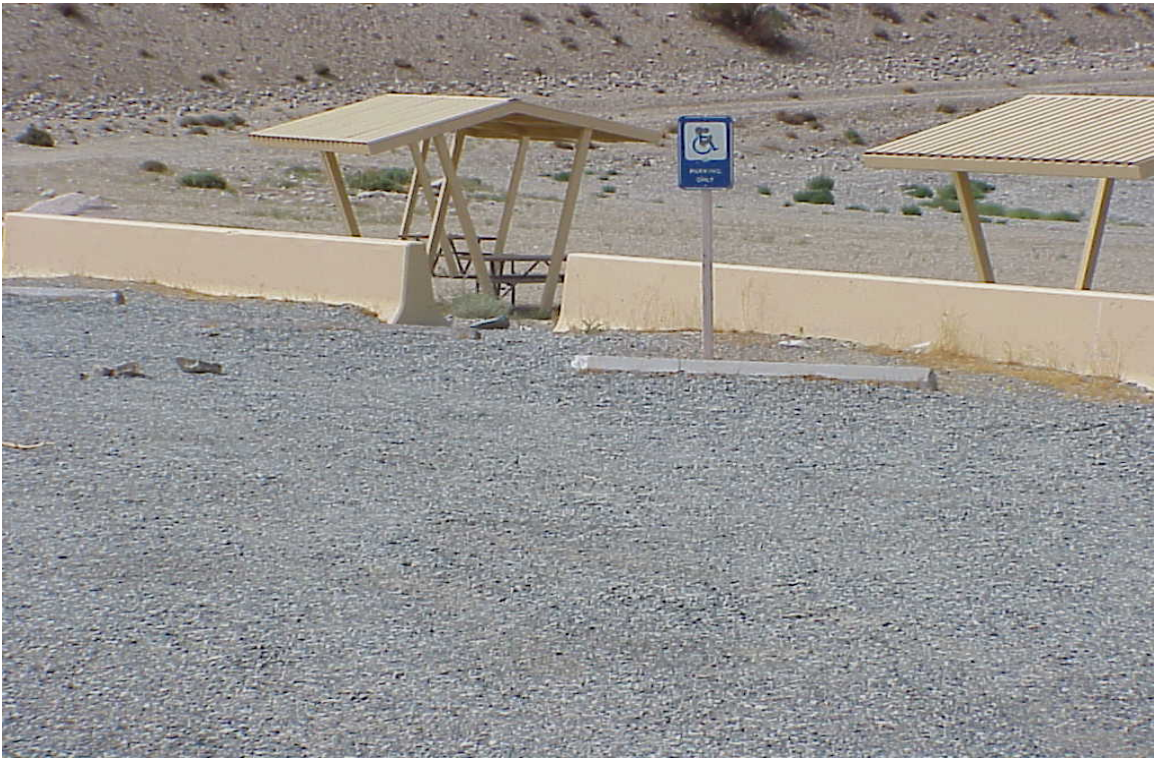
Description: ADA parking for the site.

This project provides monies for paving, striping, signage and curb stops for parking near the restrooms, and one near the ramadas. An accessible concrete path will be provided from ADA parking to a ramada, a pad around and the ramada to permit an individual in a wheelchair to sit at the table, and an accessible cooking grill provided.
