# **Grant Sawyer State Office Building** Programming and Feasibility Studies

Volume Two | Property Condition Assessment January 2, 2019

Prepared for the Nevada State Public Works Division January 2, 2019

# **Volume Two** Property Condition Assessment

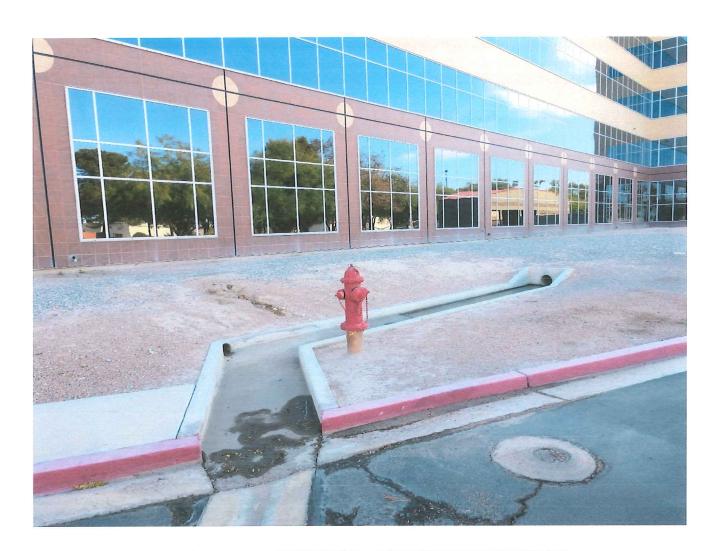
FIRE HYDRANT AND A CONCRETE THROUGH DRAINAGE LOCATED AT THE NORTHEAST PORTION OF THE SITE

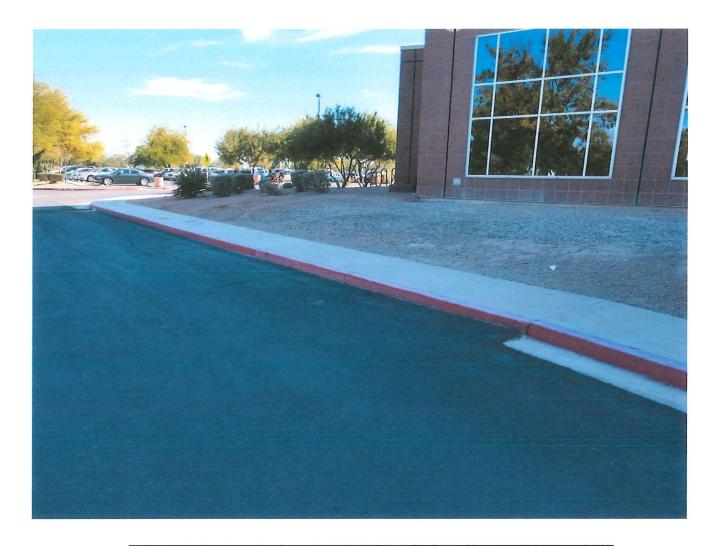
#### SIDEWALK AND PARKING AREA AT THE NORTHEAST PORTION OF THE SITE

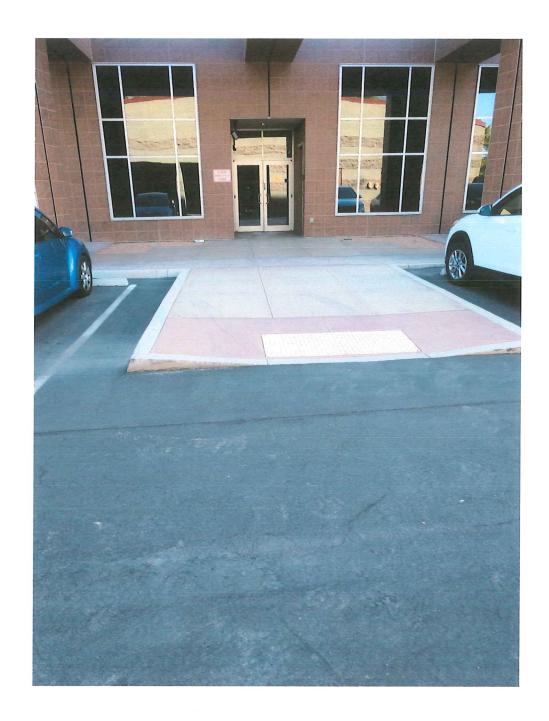
SECURED PARKING AREA TO THE NORTH

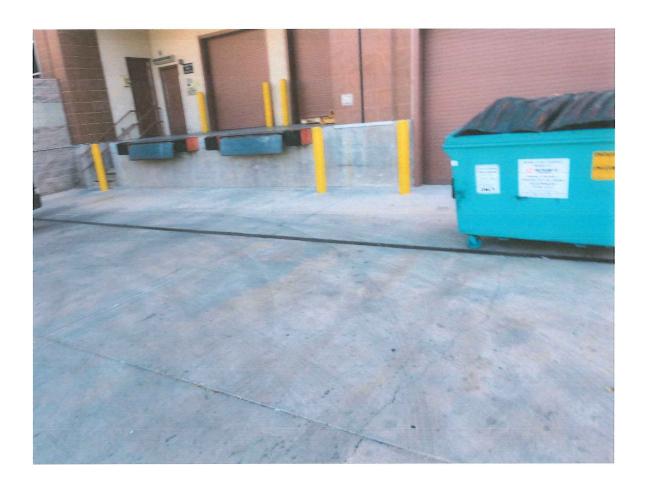
TRUCK DOCK AND TRASH AREA LOCATED NORTH OF THE SITE

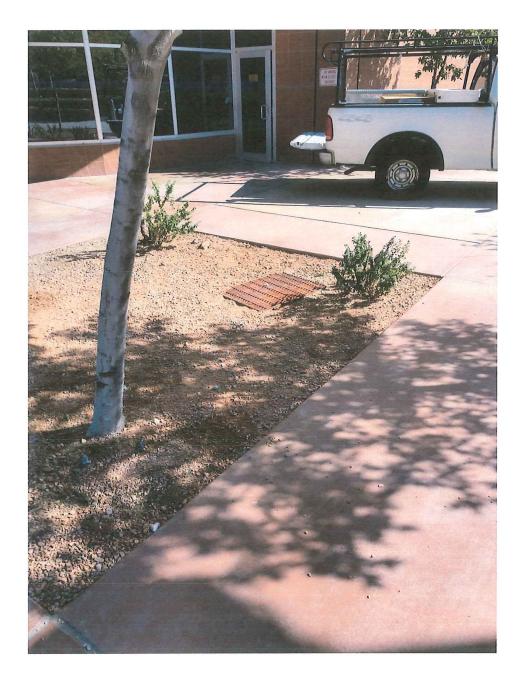
#### SEWER CLEANOUT SOUTH OF THE NORTHWEST BUILDING CORNER

WEST PLAZA AREA DRAINS NORTH

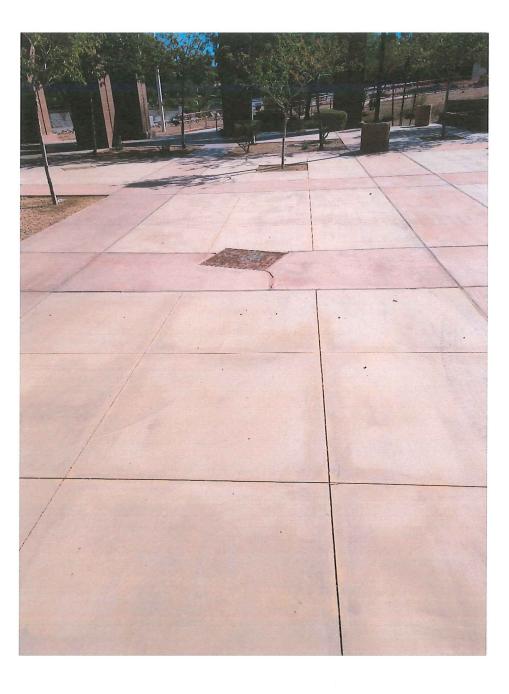
WEST PLAZA AREA DRAINS TO THE MIDDLE

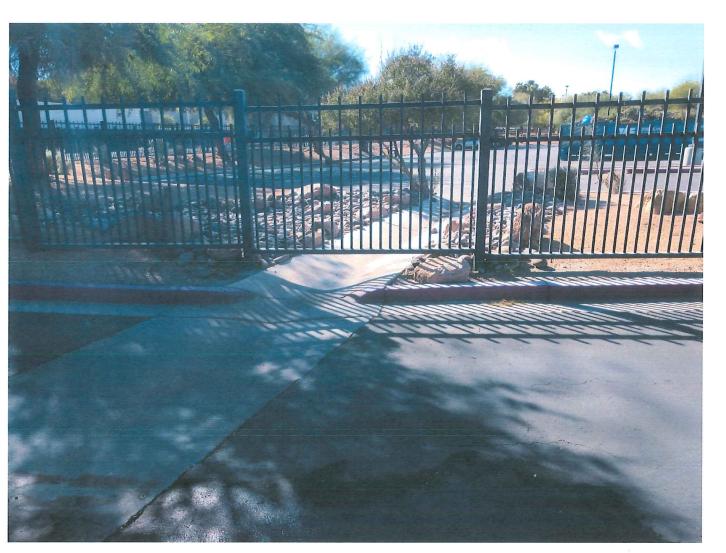
PONDING ON THE VALLEY GUTTER AT THE SOUTHEAST. NOTE THE FILL OVER PIPE VALLEY GUTTER AT THE SOUTHEAST, EXITING THE PARKING LOT

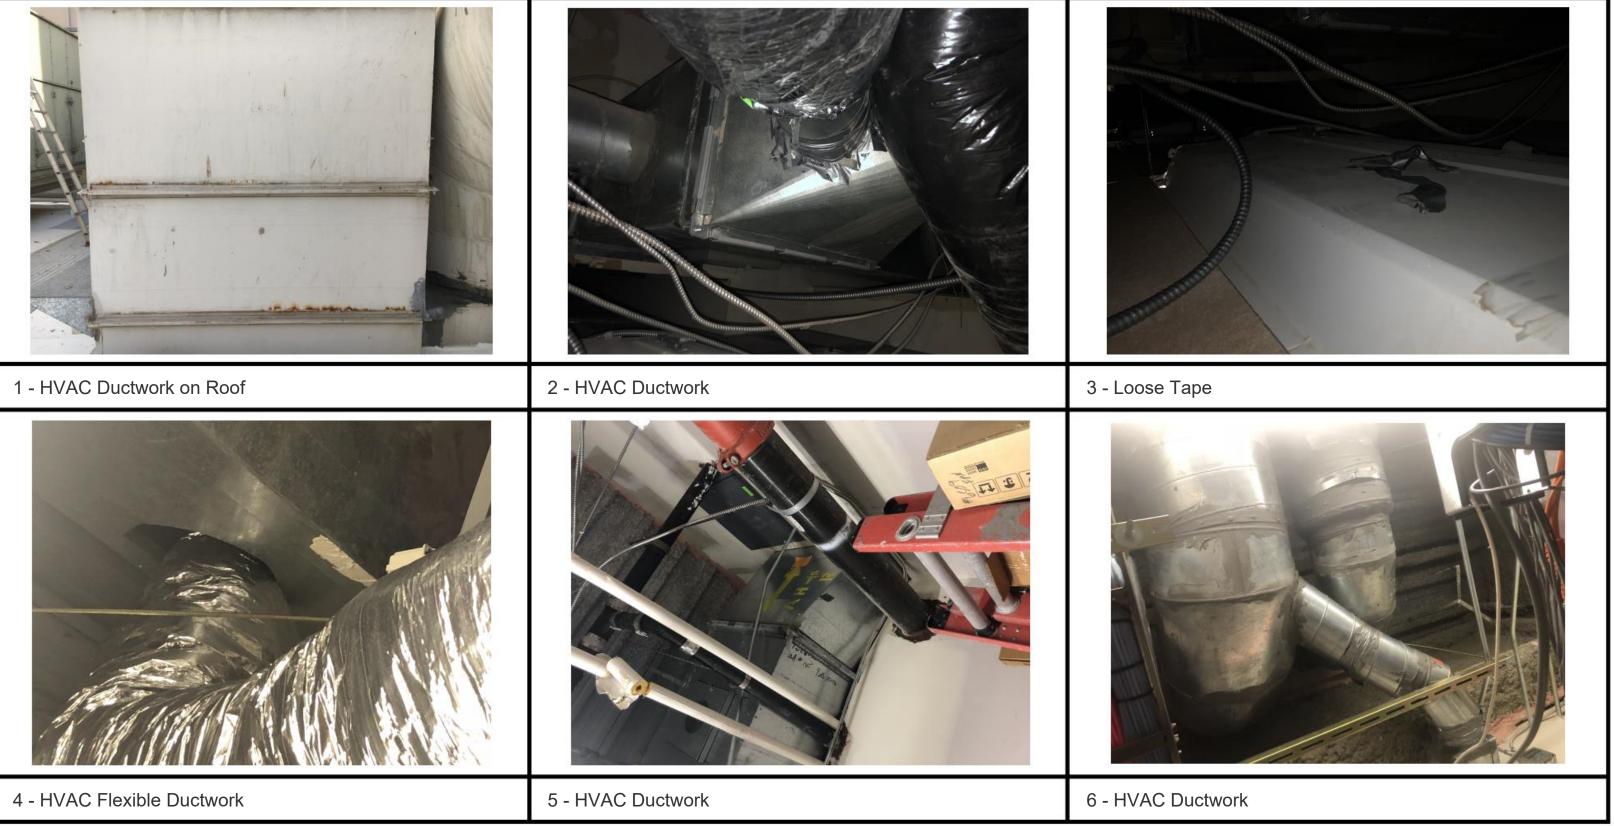
## A. Mechanical Systems and Ductwork

Conclusion: All exposed and lined medium pressure ductwork to be replaced. Exterior ductwork on roof shows the signs of corrosion and may have been compromised during the initial operation with evaporative cooling sections. Per field investigation on Level 5, multiple segments of ductwork have friable fiberglass material in the airstream as part of the original acoustical treatment of ductwork. Level 5 ductwork shall be completely removed and replaced with new ductwork.

1 - HVAC Ductwork	2 - HVAC Ductwork

Interior medium pressure ductwork compromised with openings & flex duct connections for additional cooling of server rooms shall be repaired by disconnecting of flex ductwork and properly sealing the system.

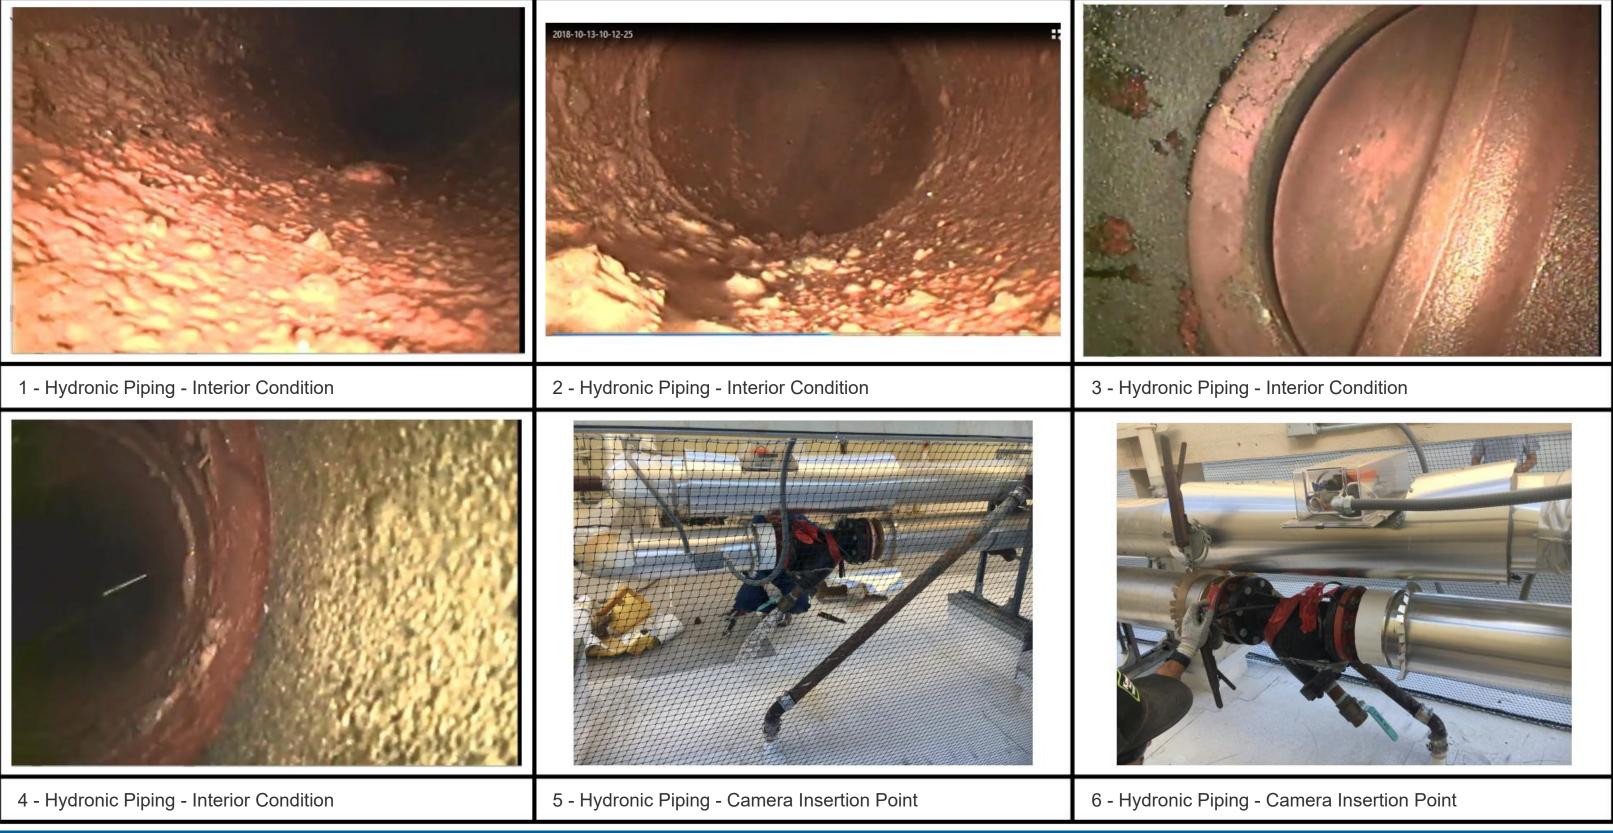
### **C. Hydronic Piping - Interiors**

Conclusions: Chilled water hydronic piping shows considerable exterior corrosion at the multiple fittings, takeoffs and elbows, due to incorrect insulation type and compromised vapor barrier or damaged service jacket. To mitigate this issue, complete chilled water piping system shall be replaced and 100% of the insulation shall be replaced with rigid polyisocyanurate insulation with correct vapor barrier and provision of dams at each pipe fitting to prevent any condensation.

The heating hot water hydronic piping shall be completely removed and replaced with new piping per current standards.

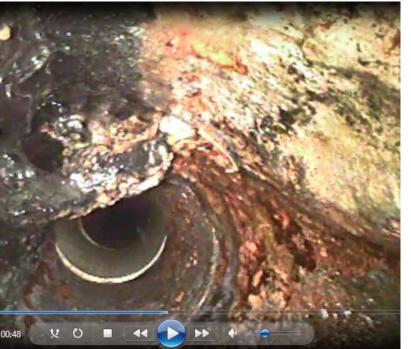
### G. Plumbing Systems - Waste and Vent - Interiors

2018-10-11-16-42-54
1 - Plumbing Systems - Underground - Collapsed Cast Iron	2 - Plumbing Systems - Underground - Collapsed Cast Iron	3 - Plumbing

ng Systems - Underground - Collapsed Cast Iron

Conclusions: Complete underground cast iron piping to be removed and replaced with PVC properly sloped system with 2% slope.

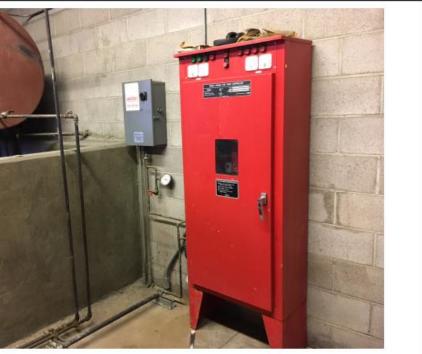
### J. Plumbing Systems - Fire Pump Room

<image/>	<image/>	PSDH CO3 99ab F
1 - Fire Pump Room	2 - Fire Pump Room	3 - Fire Pum
4 - Fire Pump Room

Conclusion: The fire pumps shall be replaced with electrically driven fire pumps per 2018 IBC.
